# Manhole Inspection Summary

Manhole # S23M\_\_002MH

Insp Date: **6/17/08 8:09 AM**

**Location** Address: **436 Cole St**

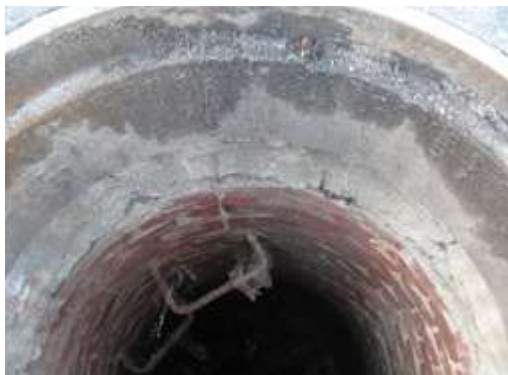
Defect 3

Condition: ☐ Sound ☐ Cracked ☒ **Leaks**

lid-frame infiltration

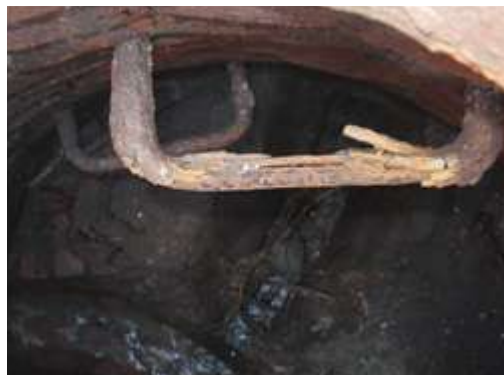
Defect 4

Count: **9**

Missing: **1**

☒ **Corroded**

missing/corroded steps

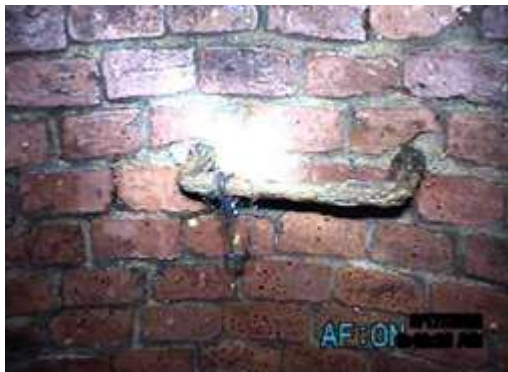
Defect 2

☒ **Evidence Of Surcharge**

Depth: **5.5** (ft.)

Surcharge Evidence

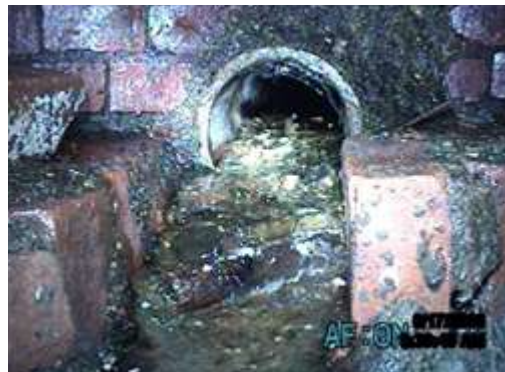
Defect 1

Condition: ☐ Sound ☐ Cracked ☐ Root Intrusion ☐ Loose Brick ☒ **Deteriorated**

Condition: ☐ Sound ☐ Cracked ☐ Root Intrusion ☐ Deteriorated ☐ Leaks ☒ **Debris**

debris in channel, Deteriorated Barrel Wall

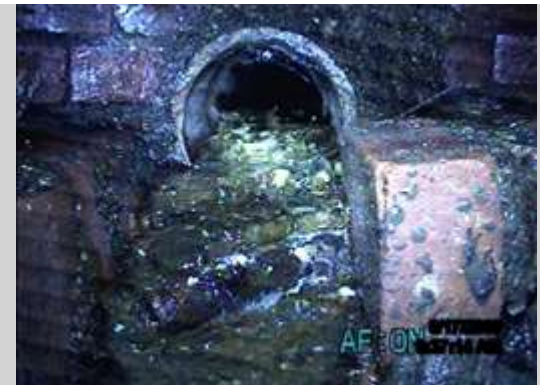
4 O'Clock Inflow

debris in channel

Pipe Height: **6** (in.) Rod and Bar (Angled)  
Pipe Material: **Clay** ☐ Pipe Lined  
Invert Depth: **13.69** (ft.) Flow Characteristics: **Slow**  
Deposits: ☐ None ☐ Mud ☐ Sludge ☒ **Debris** ☐ Grease  
Silt Depth: **0** (in.) Deposits Extent: **Medium**  
Infiltration: **Evidence** Pipe Seal Cond: **Unknown**

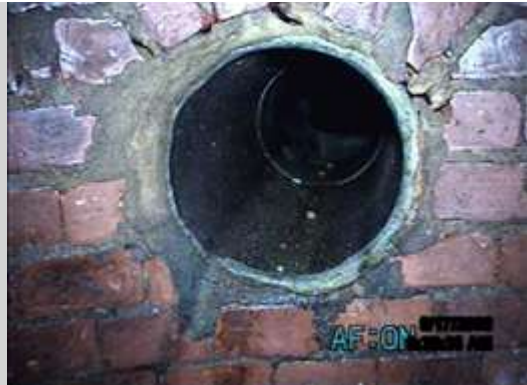
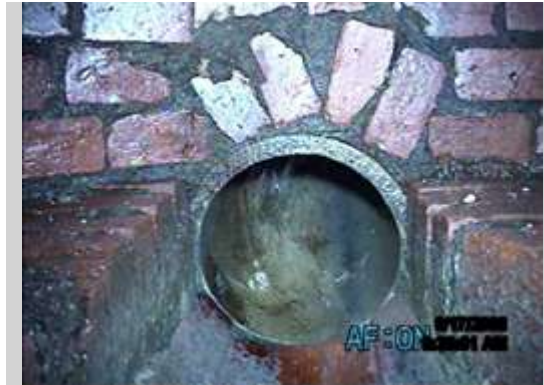
7 O'Clock Inflow

Infiltration: **Evidence** Pipe Seal Cond: **Unknown**
